# The Kursk Accident

**Statens strålevern**

Norwegian Radiation Protection Authority

Østerås, 2001

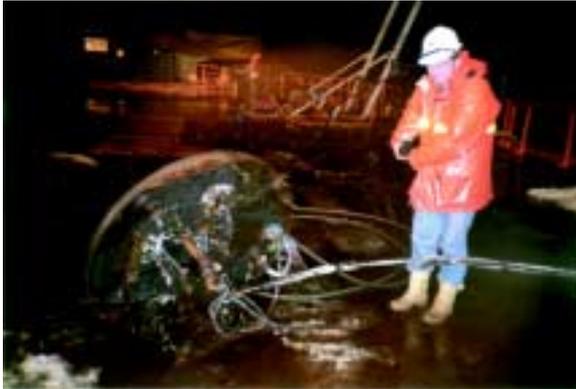
Dose rate measurements on the Regalia, of a piece of the pressure hull from compartment III.

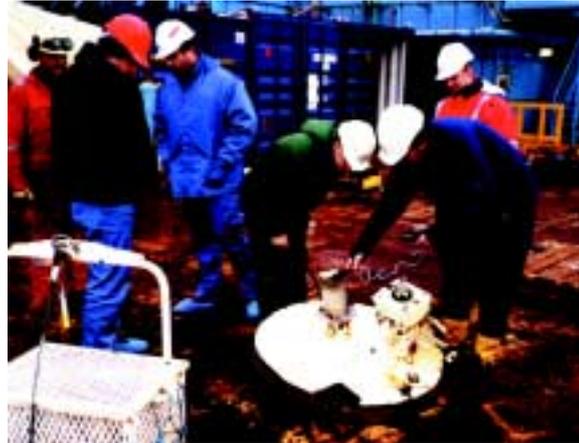
Dose rate measurements on Regalia, of a piece of the pressure hull from compartment IV.

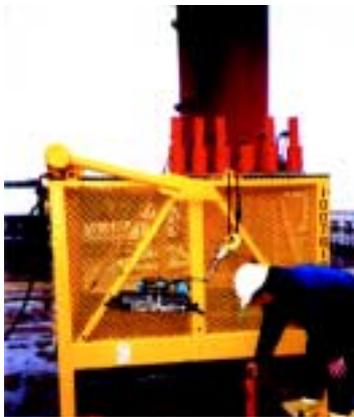
A rack of six corers, used for sediment sampling (red colour), is mounted on top of the basket. The Nansen water sampling device is mounted in front of the basket.

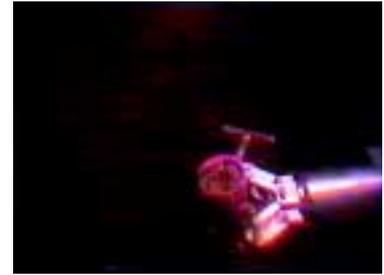
The ROV has just taken a sediment sample by use of the Titanium arm.

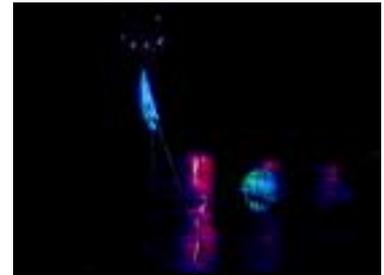
The ROV are placing the sediment sample, by use of an elastic band, to the rack on the basket located at the seabed.

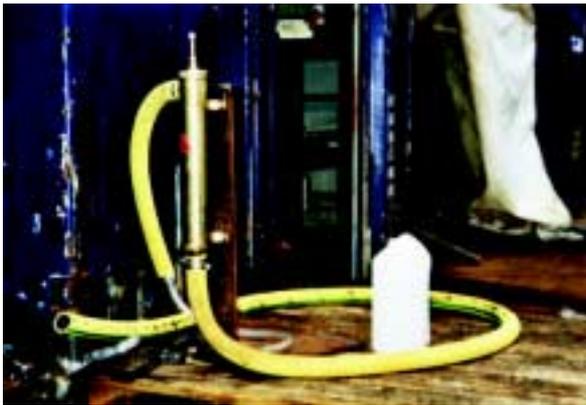
*Water sampling device used for collecting water from inside the submarine at the Regalia expedition. Flexible rubber tubes (yellow) were lowered into Kursk and into a 25 litres plastic container.*

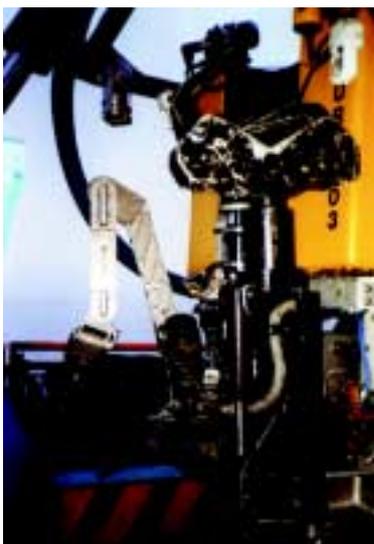
Front part of the ROV is shown with the titanium arm (left) and the dose rate meter in the water-proof housing (upper left).

Services). The ROV was equipped with an Automess 6150AD1 SF dose rate meter, which was put inside a specially made pressure-proof box and placed in front of the camera on the ROV. All the dose rate meters employed were checked against a standard radioactive source before the operation started. The readings showed good agreement, and no significant deviation was observed between the different meters.

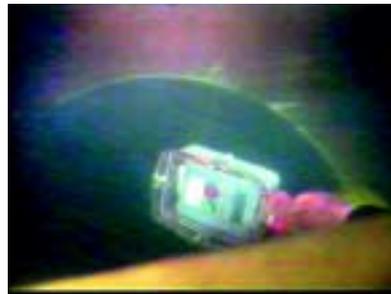
A diver is measuring the dose rate when an access hole in the Kursk is completed.

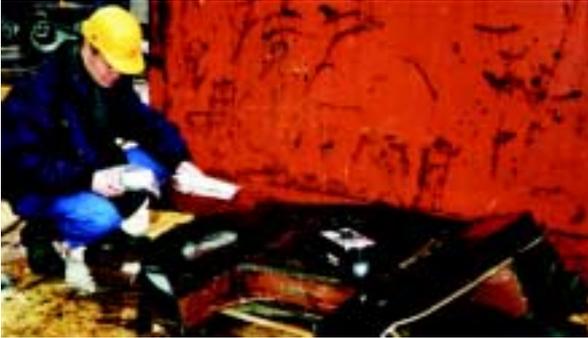
Measurements onboard the Regalia of a piece of the outer hull from compartment III.

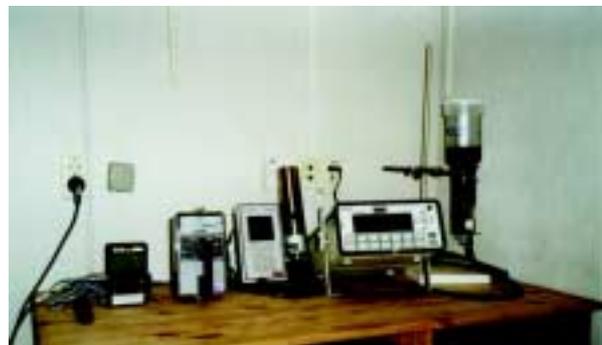
Some of the equipment at the mobile laboratory on the Regalia. From left: Automess dose rate meter; Bicron dose rate meter; EasySpec with 2" x 2" NaI detector; Canberra serie 10+ with 3" x 3" NaI detector with a 200 ml. sample box on top.

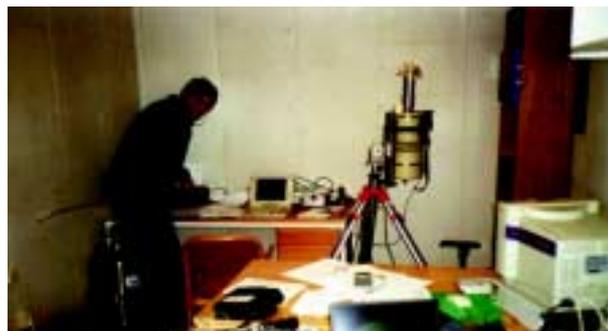
The mobile laboratory at the Regalia. A HPGe detector, mounted on a stand is shown in the back.

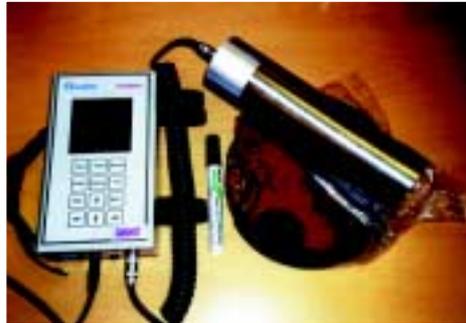
*A measurement of a piece of the pressure hull from compartment VIII is performed by use of the EasySpec multichannel analyser with the NaI detector.*

The small piece of the inner hull of compartment no. VIII was measured by the NaI detector, which was placed on top of the 50 mm thick steel piece and measured over-night. The resulting spectrum is shown in fig. 8.

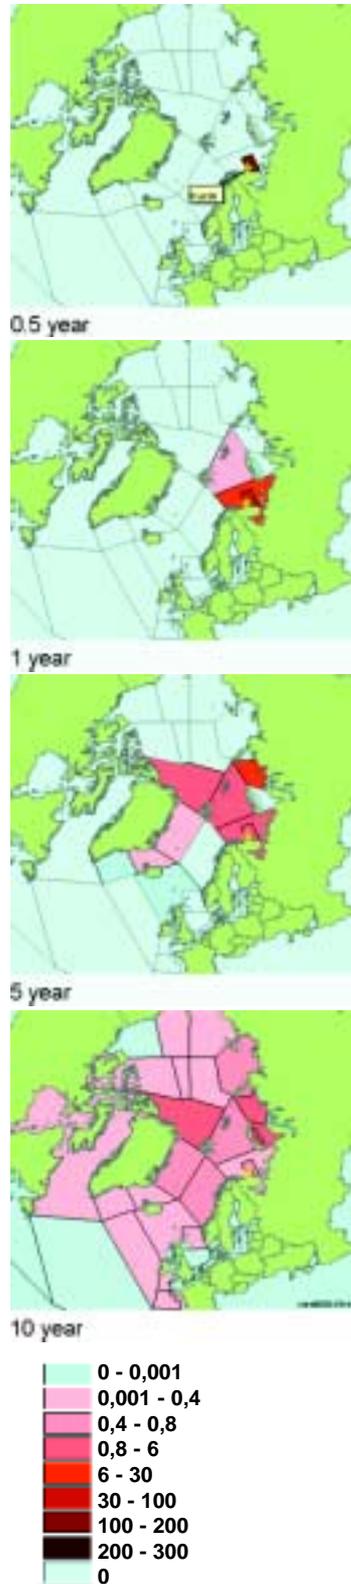
Fig. 12) Dispersion of  $^{137}\text{Cs}$  ( $\text{Bq m}^3$ ) after a potential release of radionuclides from the submarine the Kursk into the Barents Sea.

Dispersion of  $^{137}\text{Cs}$  in the oceanic water as a result of a potential accidental release from the submarine the Kursk is shown in Figure 12. The dispersion is shown for the surface water boxes relating to seafood catchments areas. Transport of radionuclides between the different boxes as a function of time is estimated. The model also includes the interaction of each radioisotope between the water- and sediment phase. However, only  $^{137}\text{Cs}$  is shown on the figure because it is by far the most significant radionuclides regarding radiation dose to man. Data on the size of the biota and fish catches in the area are included in the model.
